ENVIRONMENTAL SITE ASSESSMENT WITH TRANSMITTAL NTC ORLANDO FL  
7/15/1996  
ECG, INC.

# **ENVIRONMENTAL SITE ASSESSMENT**

**ORLANDO EXECUTIVE AIRPORT  
ORLANDO, FLORIDA**

**US ARMY CORPS OF ENGINEERS, JACKSONVILLE DISTRICT**

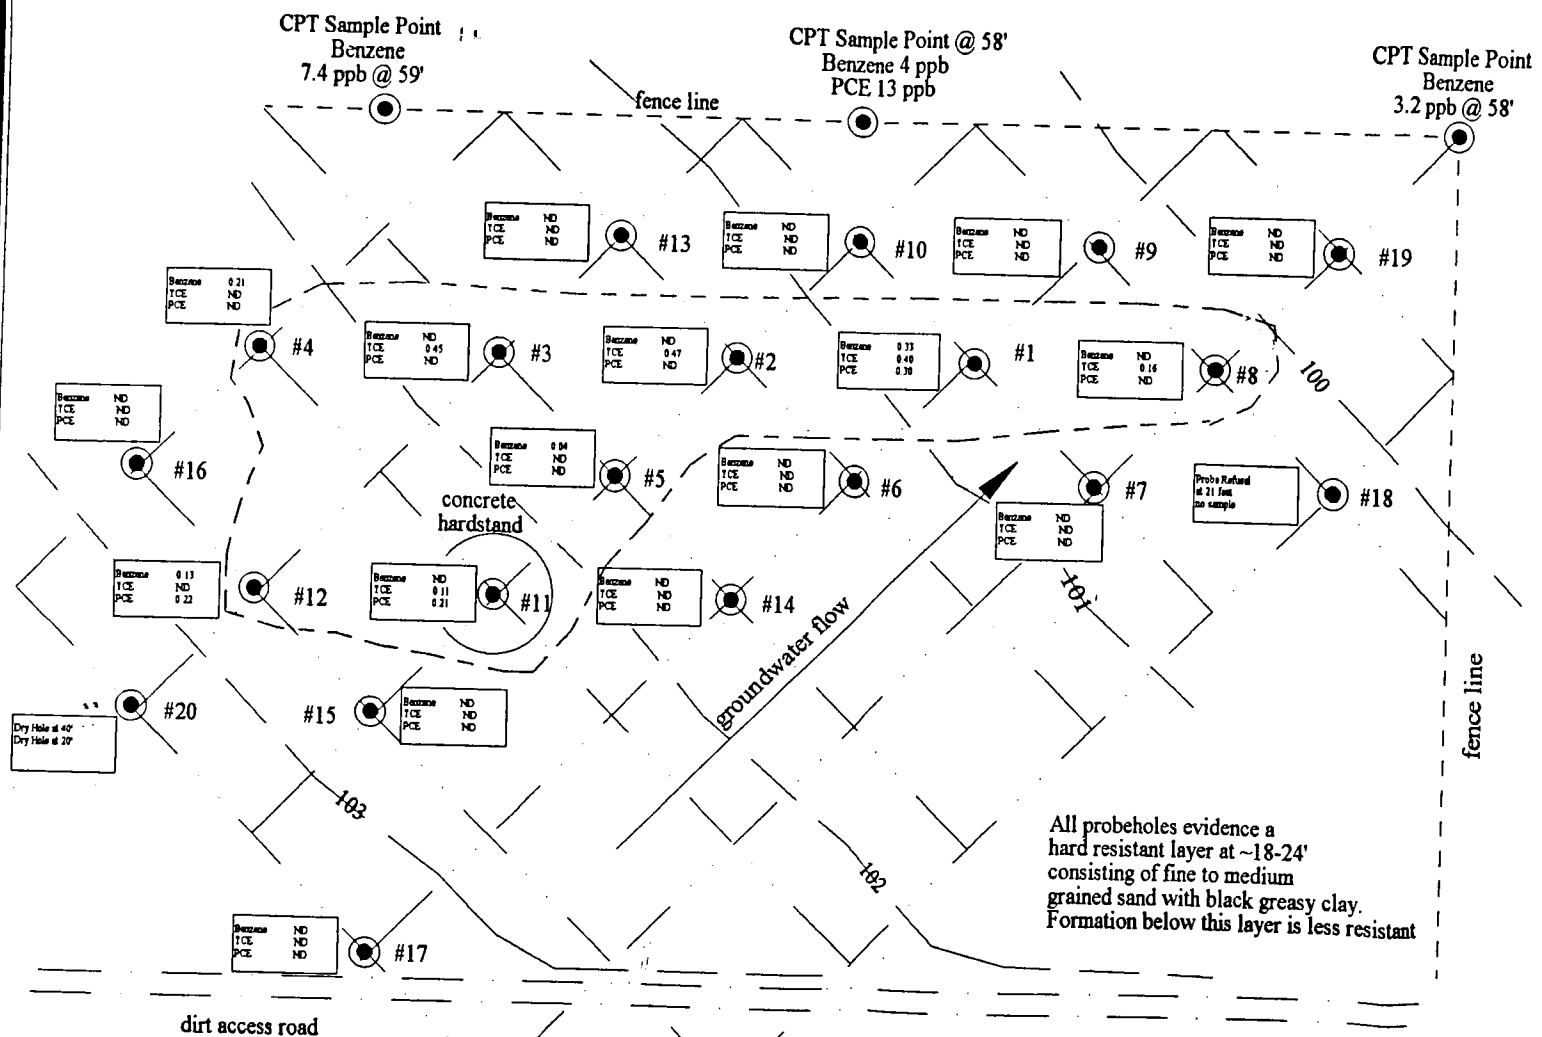
TABLE 3 RESULTS OF FIELD SCREENING

Results of these analyses are plotted and displayed graphically in figure 5. Sample results for TCE, PCE, and benzene are displayed on Tables 3 below. GC strip charts and laboratory originals can be found in Appendix B of this report.

Scale 1:600  
Figure 5
